OH-6A TAIL ROTOR TRANSMISSION GREASE EVALUATION AND FAIL DETECTION SYSTEM TEST

B.R. Smith & G. Grigorian
Hughes Helicopter Company
Centinela Ave. at Teale St.
Culver City, CA 90230

~~REDACTED~~ JUN 1977
Final Report

FINAL REPORT
ENGINEERING SERVICES CONTRACT
DELIVERY ORDER NO. 0019
TAIL ROTOR TRANSMISSION GREASE
EVALUATION AND FAIL DETECTION SYSTEM TEST

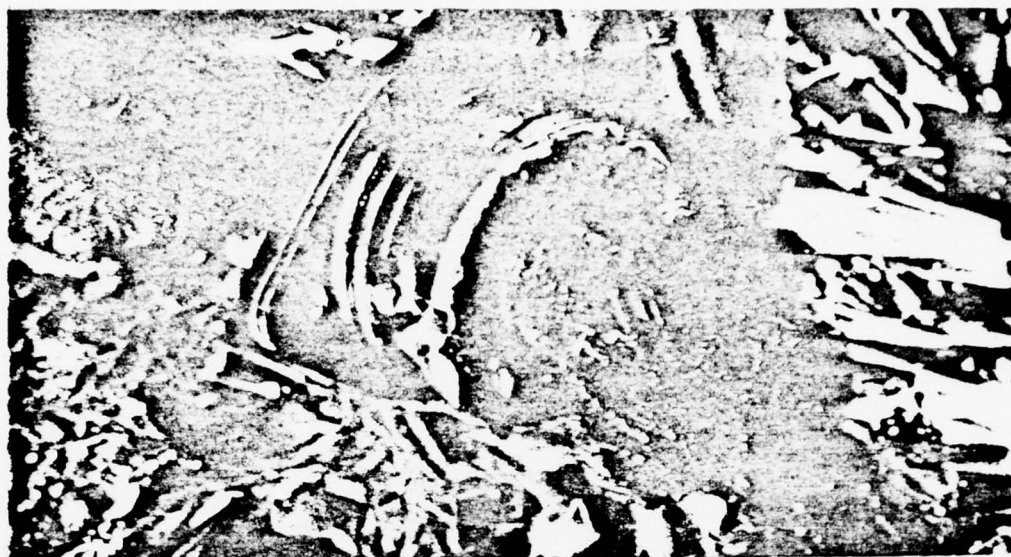
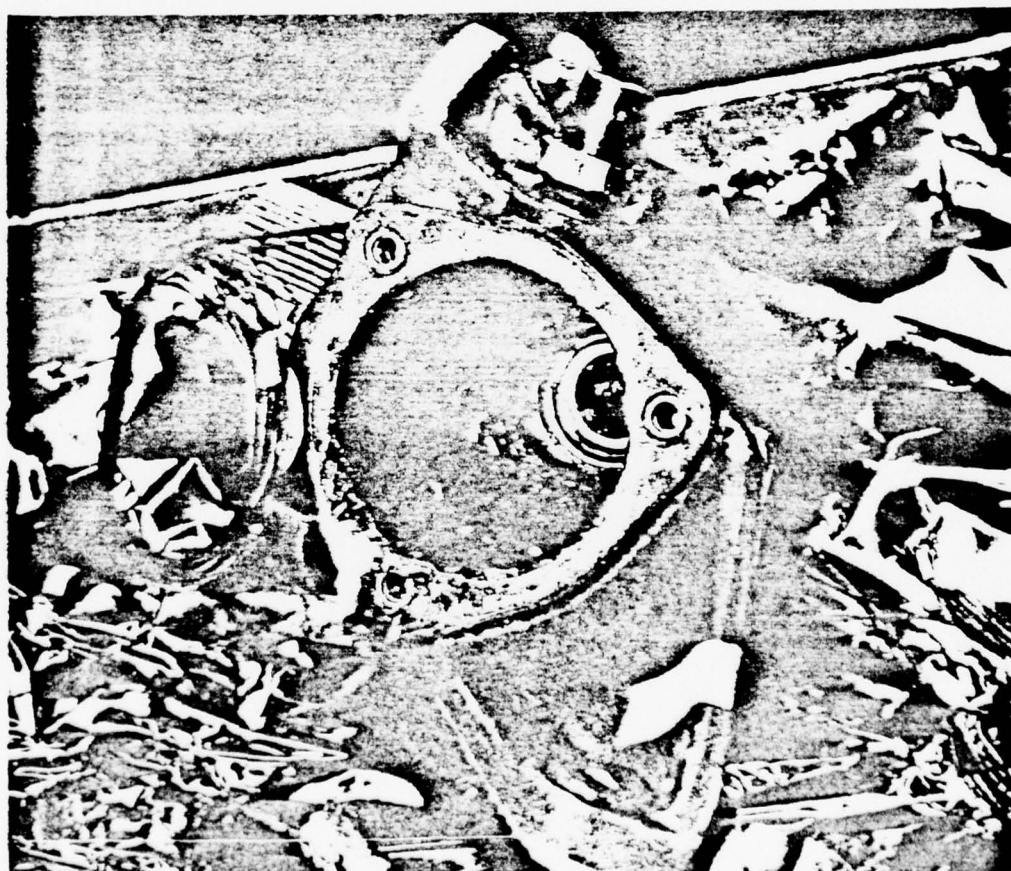
Figure 8. First Transmission Output Gearshaft and Housing
(OH-6A)

1. The gear teeth appeared to be well coated with grease (see Figures 8, 10 and 12)
2. The roller bearing on the inboard end of the output gearshaft appeared to be adequately coated with grease (see Figures 8 and 10).
3. The seals on both shafts appeared to have significant wear.

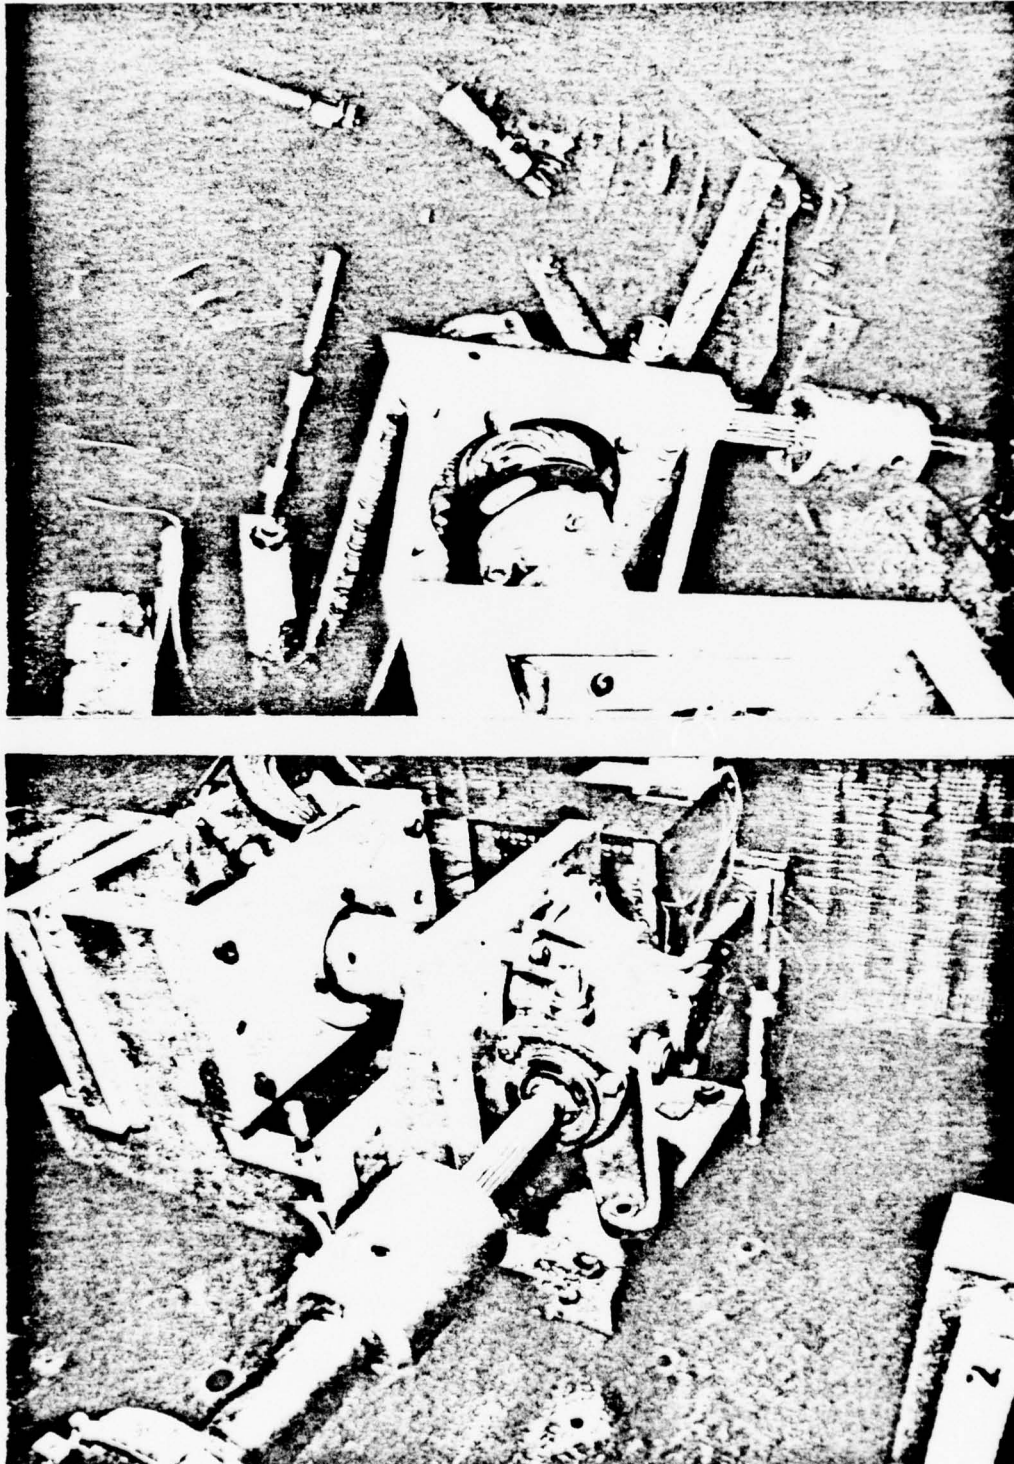
The shaft seals on both the OH-6A and the OH-58 leaked throughout the test at a rate of about 0.037 pound per 20 hours. The grease loss is not significant but deposits of grease around the shaft seals, drive couplings, and swashplates would be undesirable in that there would be an additional attraction of abrasive particles, thus accelerating the wear of drive components adjacent to the transmissions. Also, the breather on the OH-6A transmission would have to be redesigned as there is a constant undesirable internal pressure of 3 to 5 psig.

Figure 9. Grease Leakage at Seals of Second Transmission
(OH-6A)

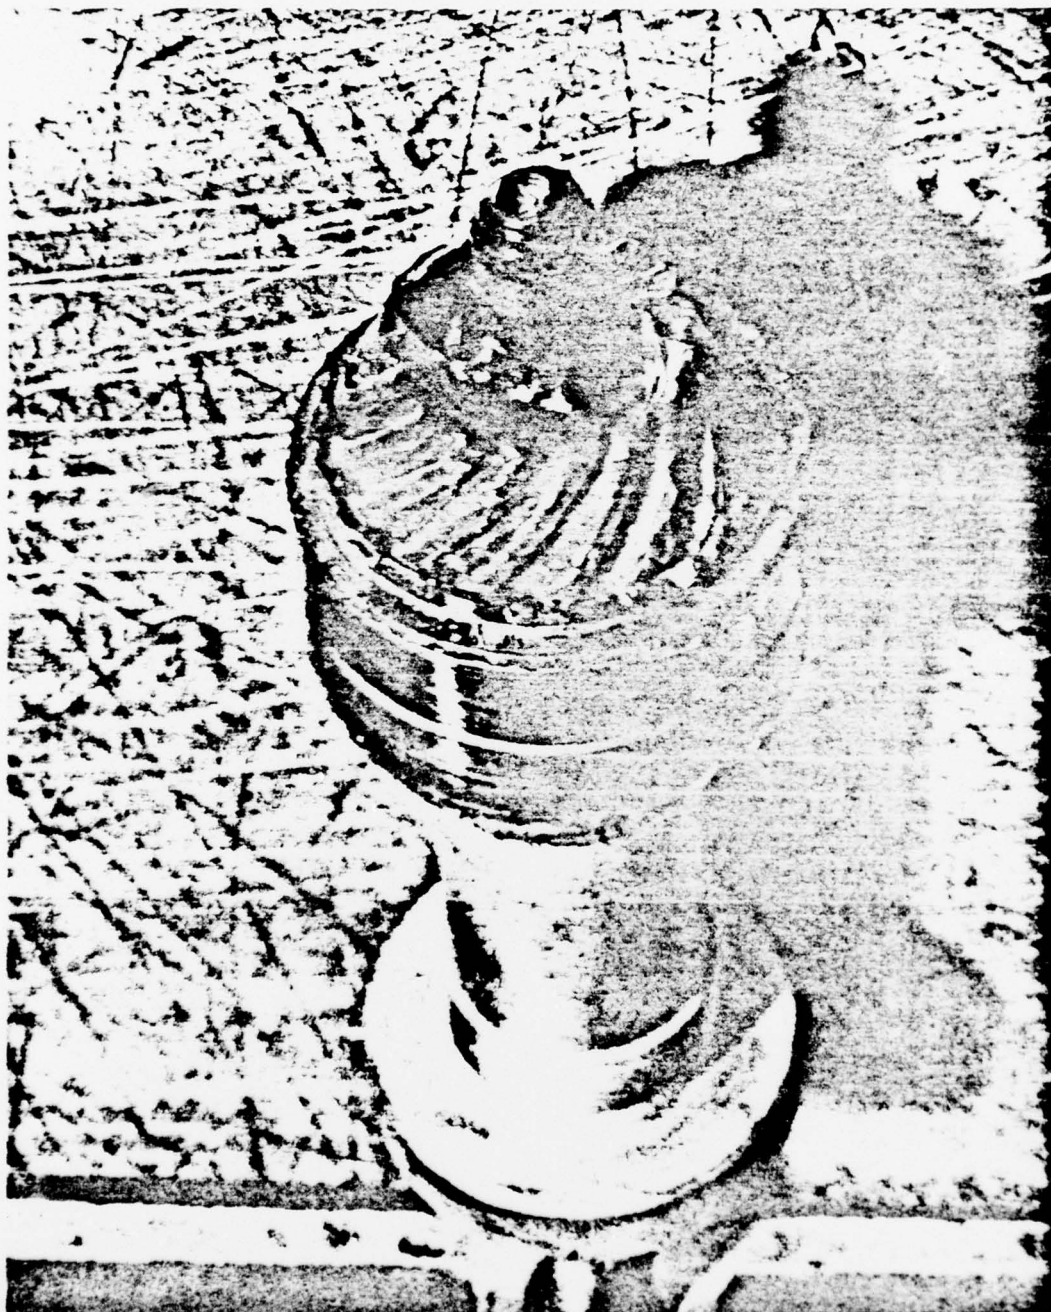
Figure 15. Input Gear Shaft, OH-58 Transmission

1. The gear teeth and bearing surfaces and housing cavities appeared to be adequately coated with grease (see Figures 15 and 16).
2. Grease discoloration from ivory to gray and black is shown in Figure 16.
3. Considerable amount of wear and scoring was noted on the gear teeth surfaces indicating that the grease was pushed out at the contact points due to excessively high test loads.

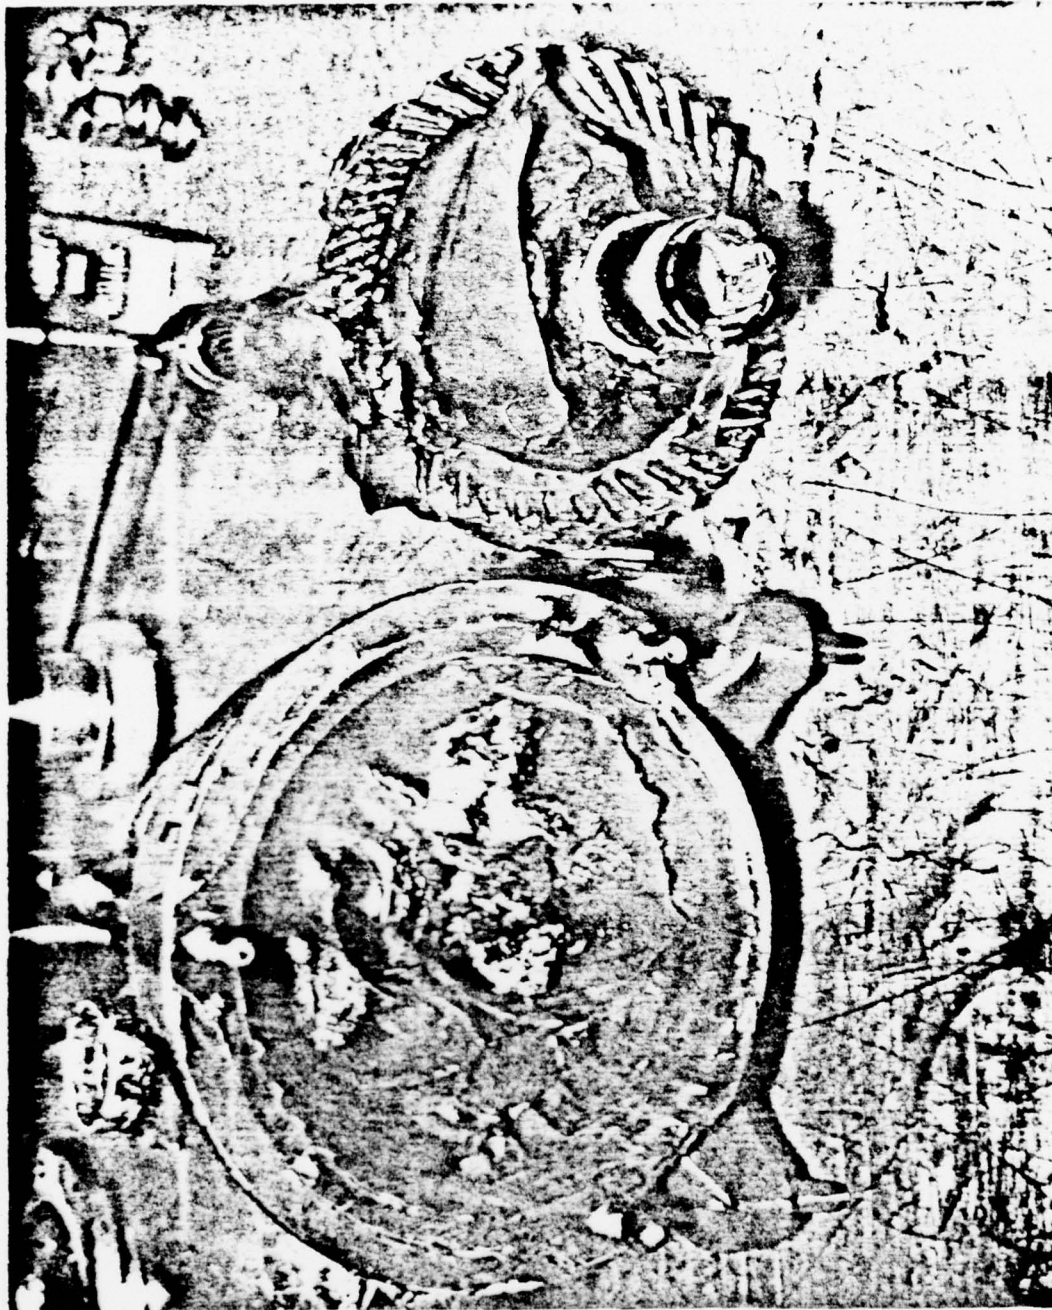
Figure 16. Grease Discoloration, Output Gear Shaft and Cavity,
OH-58 Transmission
